# **PLX SDK General Notes & FAQ**

**December 2014**

### 2.1 View PLX Driver/API Debug Messages via DebugView

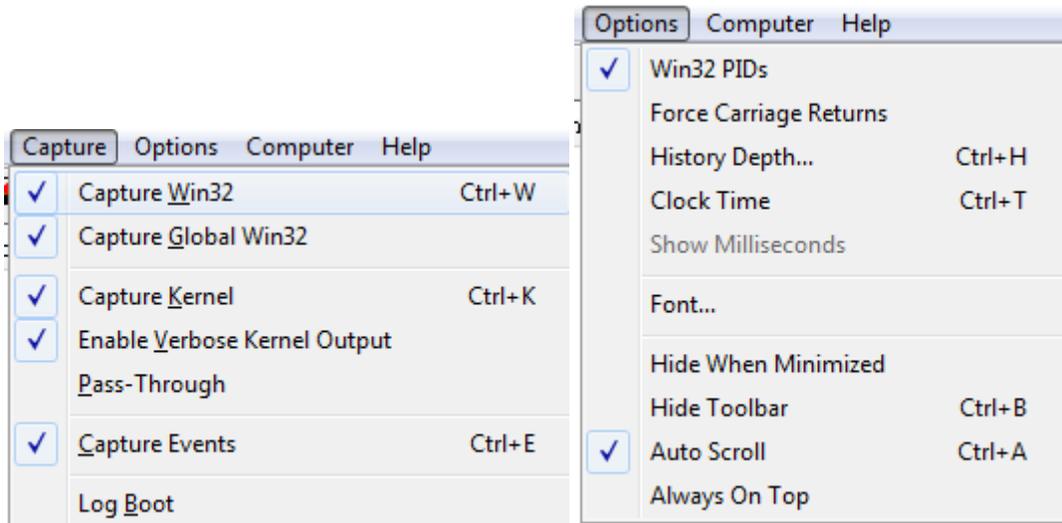
3. Setup the options as shown below

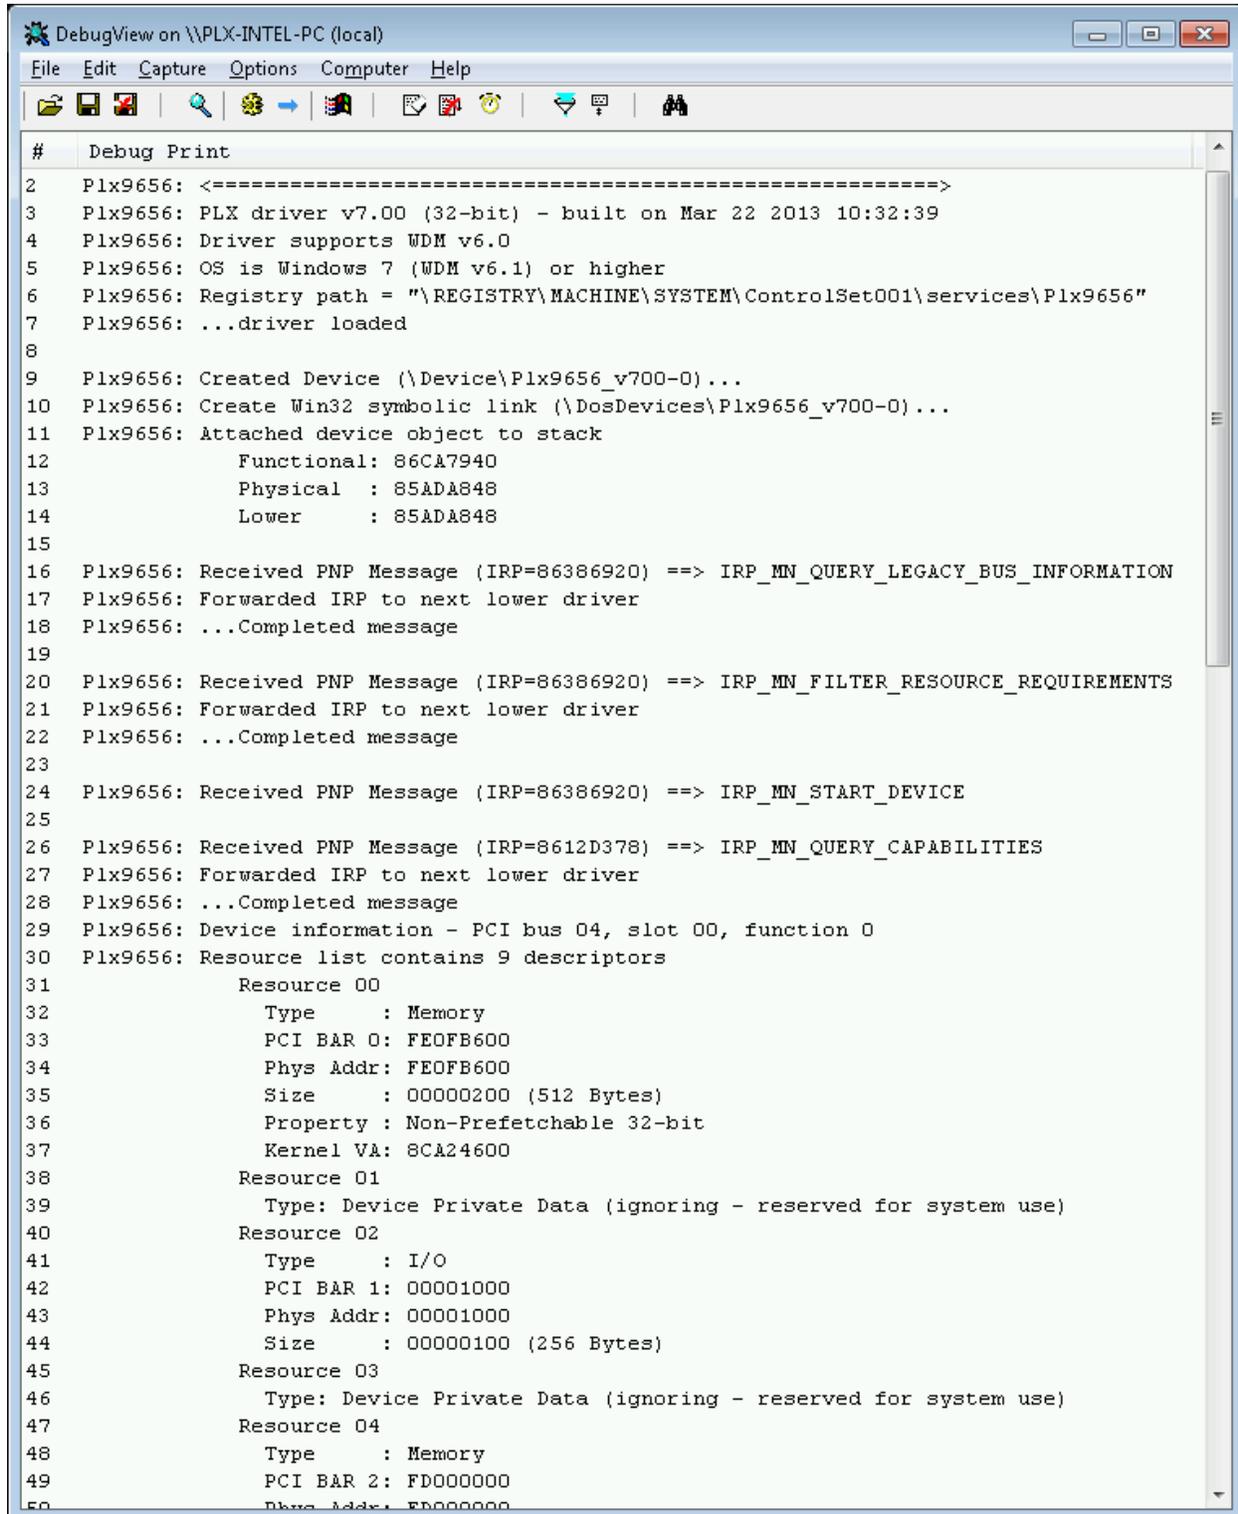
6. When the driver loads, & if everything works properly, PLX driver debug messages should appear. Debug View also allows capturing to a file, & other features. The output should be similar to the snapshots below.

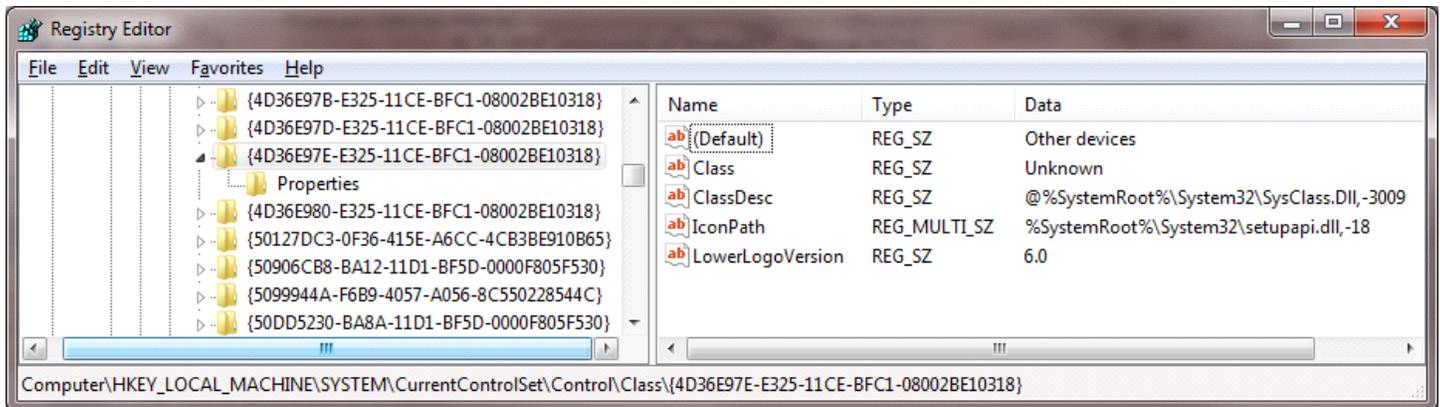
The security setting may show up in the registry under either the Device Class (governs all devices of that class) or the device-specific registry entry. For example, here's the "Other Devices" class:

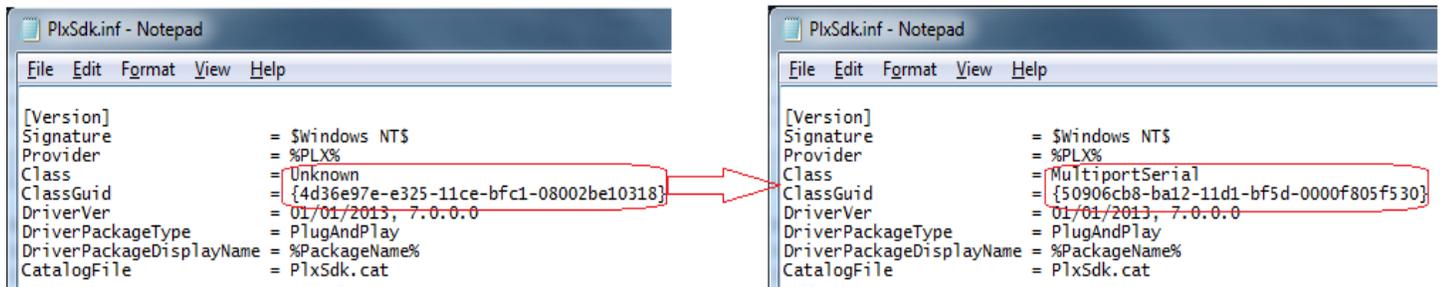
2. **[Recommended]** In the INF, modify the class to one that matches the type of device that will ship. In general, this step should be followed anyway. This change then avoids the security descriptor setting for the **Unkown** device class. Uses either a Microsoft provided Vendor class or refer to MSDN for creating a custom OEM class. Creating a custom class is beyond the scope of this document, but essentially involves adding a **ClassInstall32** section to the INF. Below is an example of changing to a Multi-port Serial Adapter class of devices.

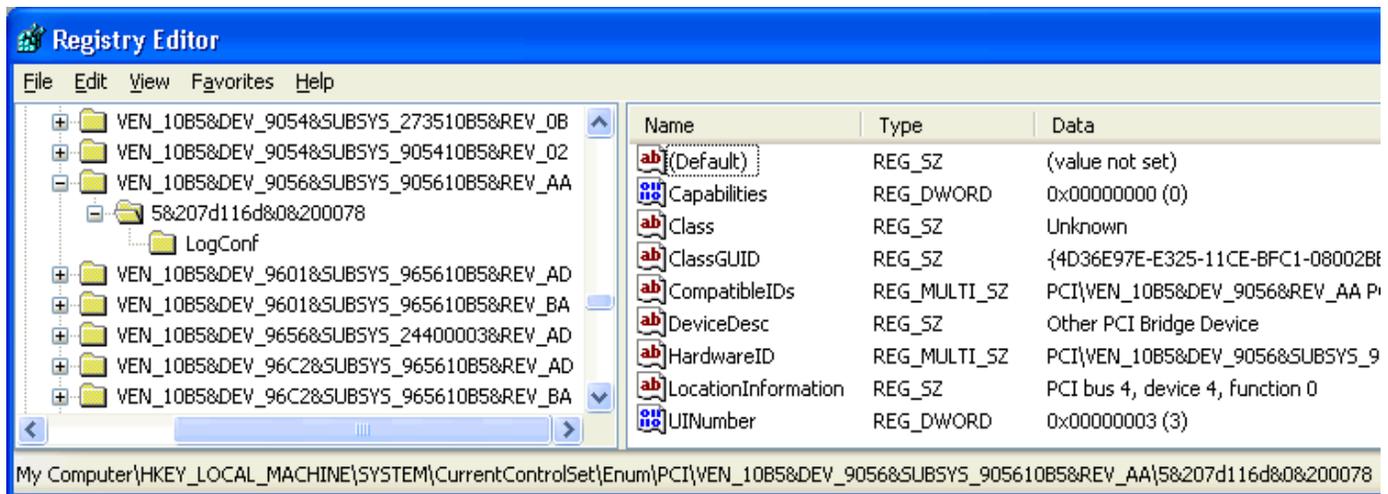
3. In the registry, check both the **Unknown** class (**HKLM\SYSTEM\CurrentControlSet\Control\Class\{4D36E97E-E325-11CE-BFC1-08002BE10318}**) location & the registry entry for the device itself. The device location will depend upon its Dev/VenID, etc., but will be a sub key under **HKLM\SYSTEM\CurrentControlSet\Enum\PCI**. Here’s an example of a PLX 9056 RDK in a system:

**If there is some sort of “Security” key under either of these, delete them & reboot & that may solve the problem. Most likely it’s under the class key.**

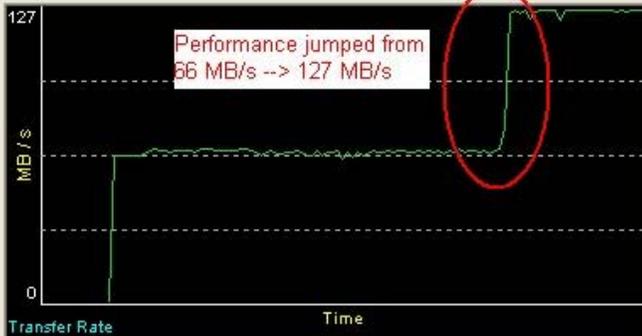
Below are some sample snapshots demonstrating the changes & performance impact on a PLX 8311 RDK.

The image shows two software windows: PLXMon and PLX Performance Measure. The PLXMon window displays register settings for two devices: 8111 BB and 9056 BA. The 8111 BB window shows the Main Control Registers, with the value 23008090 highlighted in the PCI Control register (100C). The 9056 BA window shows the PCI Registers, with the value 00005008 highlighted in the Hdr Type / Cache Line register (0C). The PLX Performance Measure window shows the DMA configuration and performance statistics. The DMA configuration includes PCI Address (00060000), Local Address (00000000), Channel (0), Use (Polling), and Global Options (Transfer: PCI ==> Local, Local Burst: Infinite). The performance statistics show a total of 515,621 transfers, 503.54 MB of data, and an overall rate of 76.55 MB/s. A graph shows the transfer rate over time, with a red arrow pointing to the start of the DMA test at 17MB/s.

**Set PF to 512B in 8111 resulted in 52MB/s**

**Increase PCI Latency timer from 20h --> 50h reached 76.5MB/s. Without this, DMA maxed at 18MB/s regardless of 8111 PF.**

**DMA starts at 17MB/s**

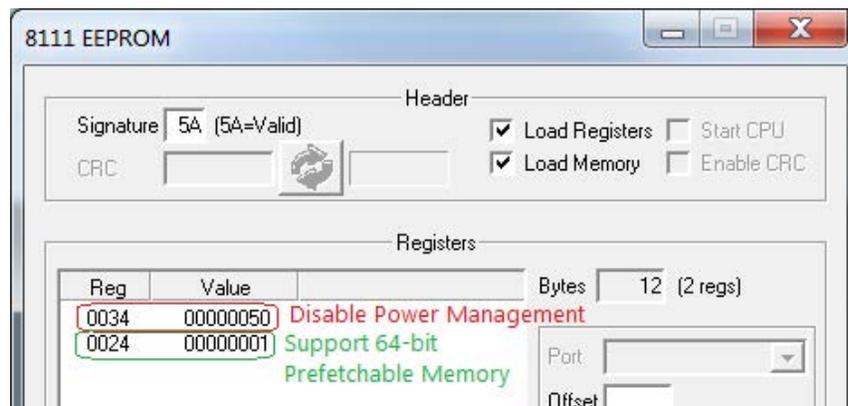
To disable PM, add the value **50h** for offset **34h** in the SPI EEPROM. The PM Capability is located at 40h in the 8111, so placing a value of 50h in 34h “hides” this capability from the Operating System by bypassing it in the PCI Capabilities list.

Upon reboot, verify 50h is loaded into 34h.

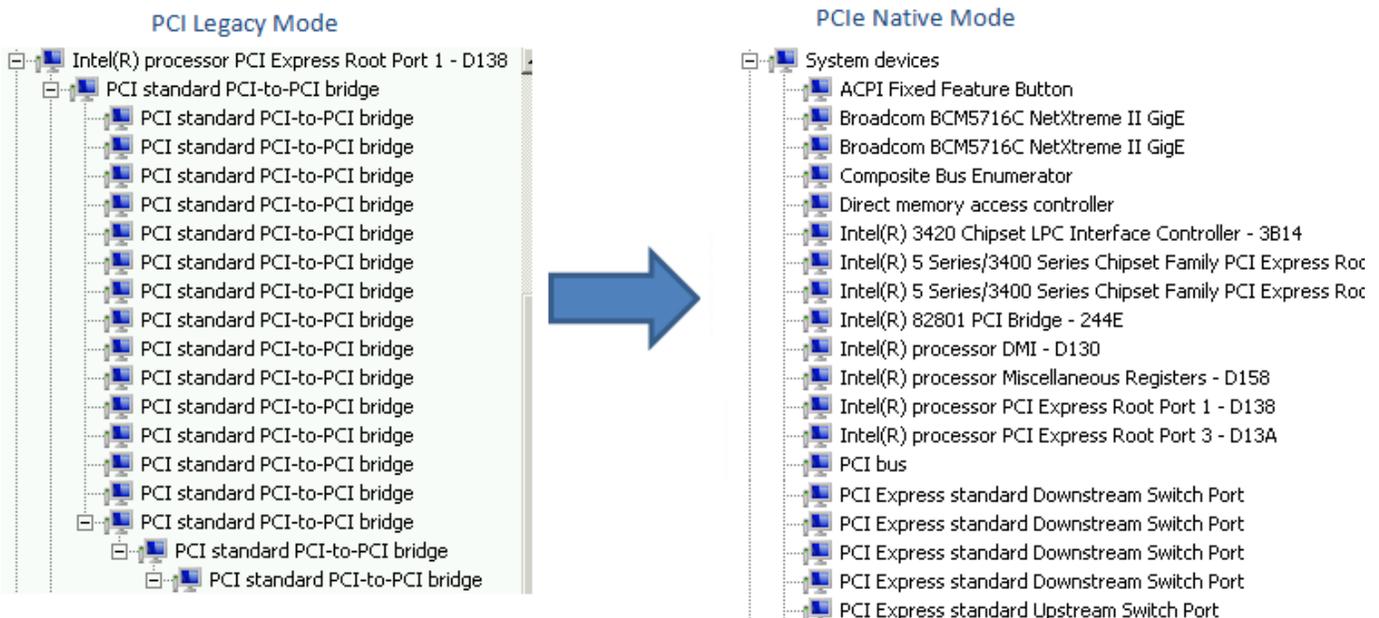
There is no obvious way to detect which mode Windows is running in. One method PLX has noticed is in Device Manager, the description of PCIe upstream & downstream ports will be different between PCI Legacy and PCIe Native modes. In PCIe Native mode, switches are listed as *“PCI Express standard Upstream/Downstream Switch Port”*, whereas they are *“PCI standard PCI-to-PCI bridge”* in Legacy mode.

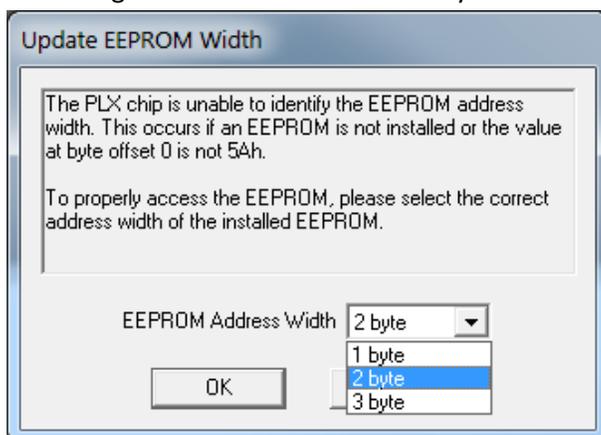
- **[8700 & newer 8600 series]** These PLX devices support manual override of the EEPROM byte addressing in the memory controller. 260h[21] is the manual override bit & 260h[23:22] set the byte address width. 260h[21] must be set 1<sup>st</sup> & remain set to keep the override in effect. To program a blank EEPROM, perform one of the following depending upon the method used:
  - **[PLXMon GUI]** PLXMon will query the PLX chip & prompt the user if the byte addressing is not set with the dialog below. Select the correct byte addressing.
